### **PROJECT #153K BEHAVIOR OF CORRODED PIPELINES UNDER CYCLIC PRESSURE**

Report Title: Project #153K Behavior of Corroded Pipelines under Cyclic Pressure	
Report Number: R8928	Project SAP Code: 1/07620

This report presents the results for Project #153K, "Behavior of Corroded Pipelines Under Cyclic Pressure".

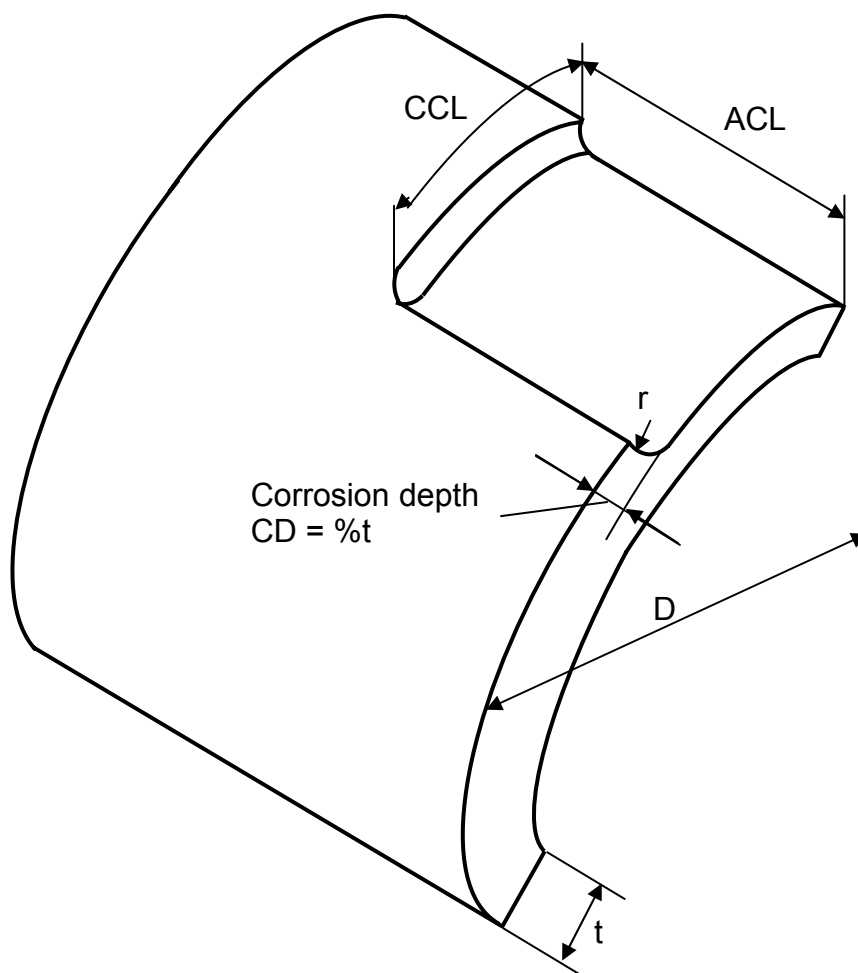
Figure 1. Geometrical Definition of Corroded Pipe

Both the axial corrosion length (ACL) and the circumferential corrosion length (CCL) in Figure 1 vary from 13 mm to 500 mm. The corrosion depths (CD) modeled were 20%, 40%, 60% and 80% of the pipe wall thickness. These were chosen to cover a range slightly deeper than the typical manufacturing under tolerance of 10% through to a depth of 80%, where assessment codes such as ASME B31.G [9] require repair. It should be noted that only one quarter of the corrosion area is shown in Figure 1, therefore ACL and CCL represent half of the total axial corrosion length and half of the total circumferential corrosion length, respectively. The corrosion defects have been idealized as having a smooth transition radius and a flat bottom.

The radius at the transition region around the corrosion edge in Figure 1 is  $r = t$  ( $r/t = 1$ ) for most of analyses. The effect of varying the radius  $r$  was investigated for 914.4 mm x 12.7 mm pipes by reducing the transition radius to  $r/t = 0.5$ .

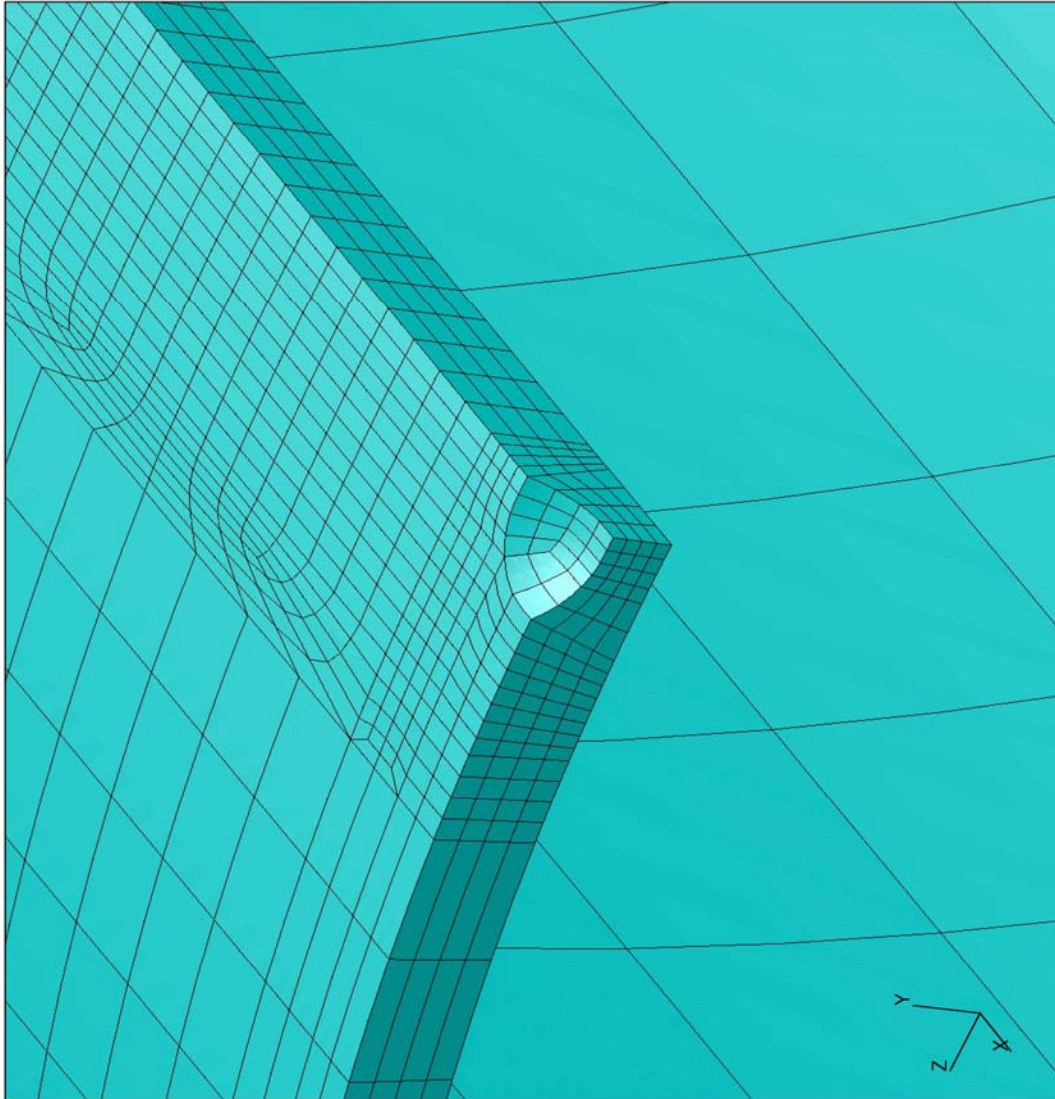
The finite element models were constructed using the PATRAN 2001 r3 [8] mesh generating software and analyzed using the general-purpose FE code ABAQUS version 6.4 [10]. Typical meshes generated for the assessment are shown in Figure 2 - Figure 5 with  $r/t = 1$ , CD = 40% and the corrosion size ACL x CCL = 13 mm x 13 mm, 13 mm x 500 mm, 500 mm x 13 mm and 500 mm x 500 mm, respectively. The models used quadratic cubic elements (20 node bricks), with the mesh design based on previous studies of the behavior of corrosion defects carried out by Advantica. Figure 2 represents a small circular pit, whilst Figure 3 is a long circumferentially oriented groove, such as might occur with preferential girth weld corrosion. In Figure 4 the groove orientation is axial. A square patch is shown in Figure 5; this has radiused sides and corners. Figure 6 shows the mesh for a defect with a smaller transition radius,  $r/t = 0.5$  but with the other dimensions, (CD = 40% and ACL x CCL = 13 mm x 13 mm) identical to those in Figure 2. The smaller transition radius has resulted in short straight sections at the edges.

Figure 2 – Finite Element Mesh of 914.4 mm x 12.7 mm Pipe with a Corrosion Size of 13 mm x 13 mm and a Depth of 40% Wall thickness ( $r/t = 1$ )

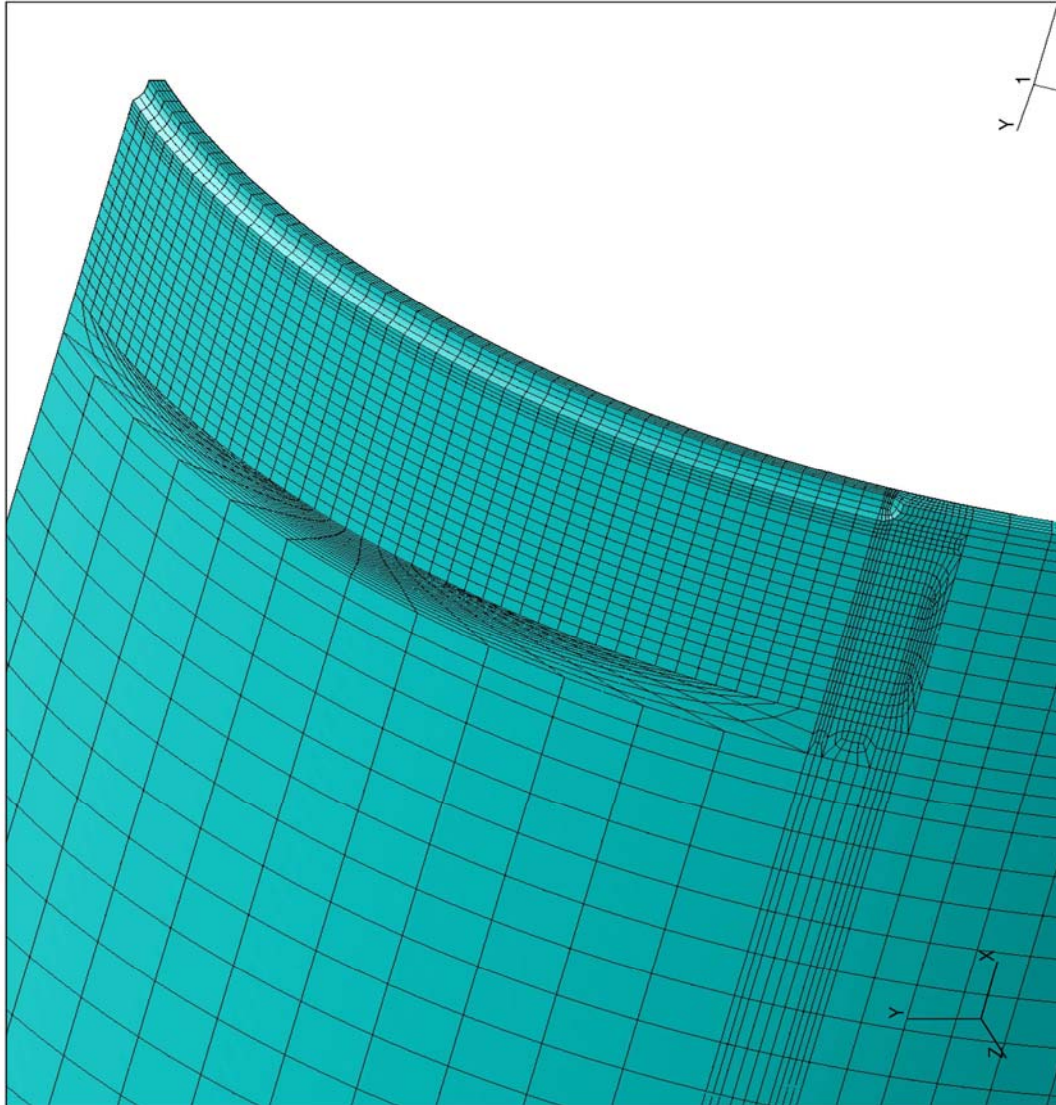
Figure 3 – Finite Element Mesh of 914.4 mm x 12.7 mm Pipe with a Corrosion Size of 13 mm x 500 mm and a Depth of 40% Wall thickness ( $r/t = 1$ )

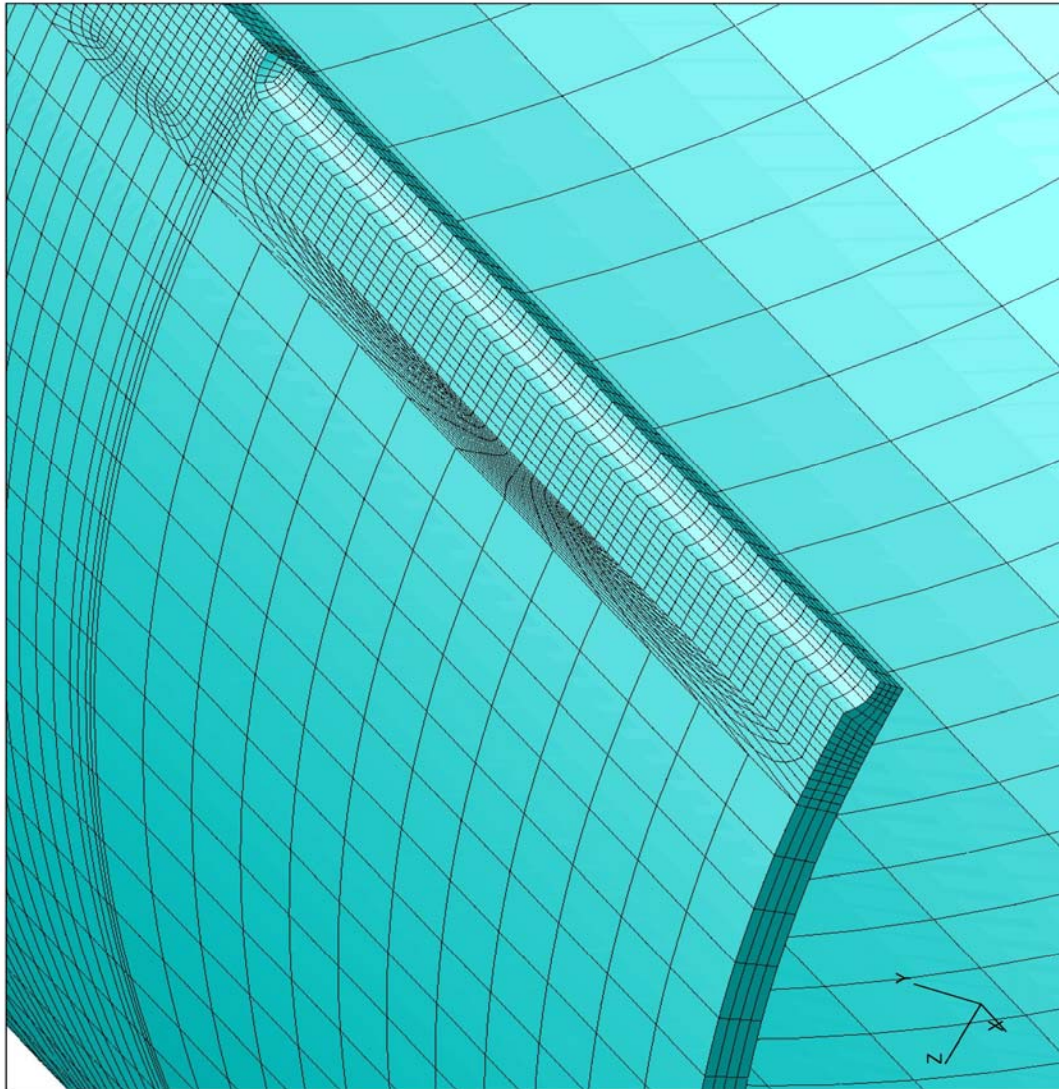
Figure 4 – Finite Element Mesh of 914.4 mm x 12.7 mm Pipe with a Corrosion Size of 500 mm x 13 mm and a Depth of 40% Wall thickness ( $r/t = 1$ )

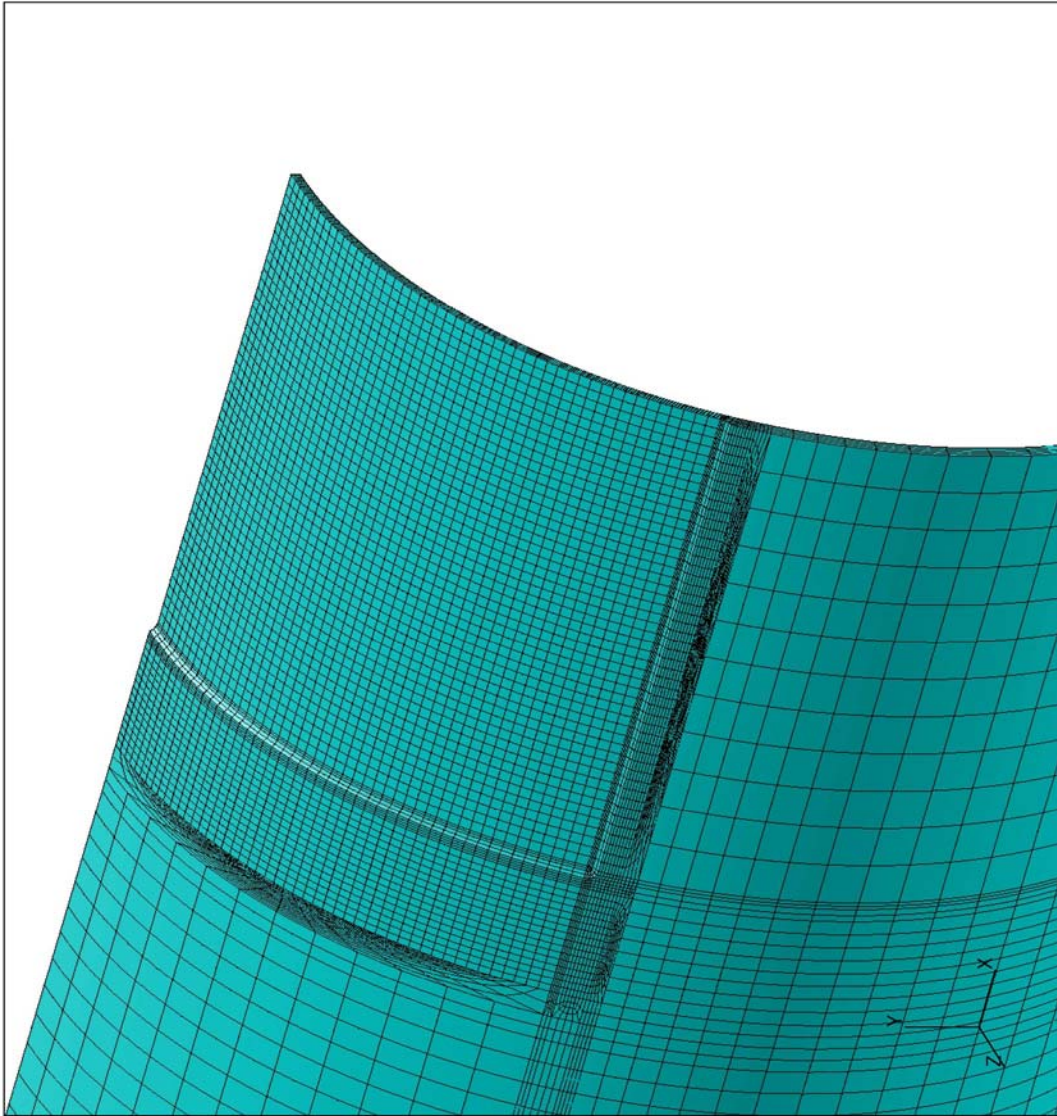
Figure 5 – Finite Element Mesh of 914.4 mm x 12.7 mm Pipe with a Corrosion Size of 500 mm x 500 mm and a Depth of 40% Wall thickness ( $r/t = 1$ )

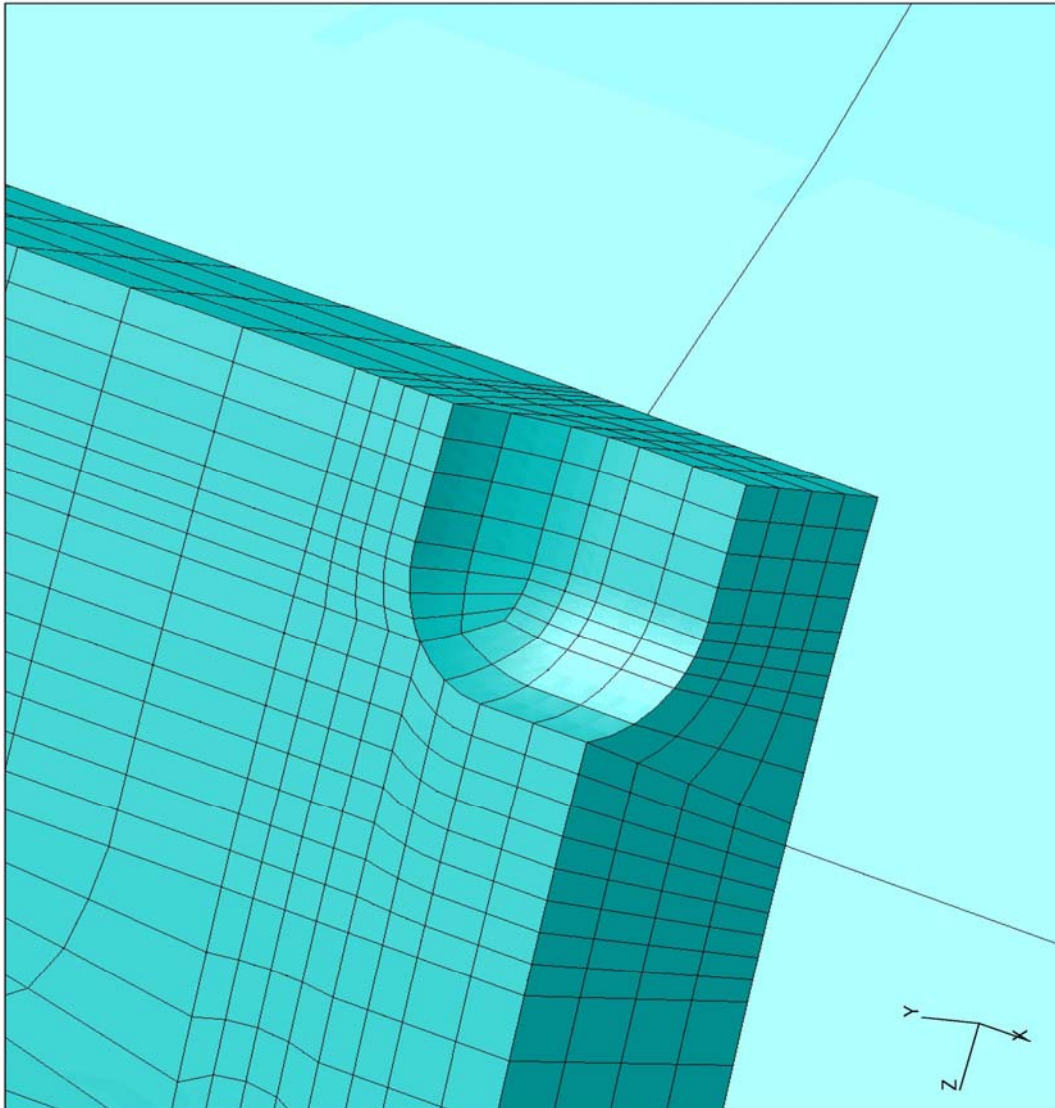
Figure 6 – Finite Element Mesh of 914.4 mm x 12.7 mm Pipe with a Corrosion Size of 13 mm x 13 mm and a Depth of 40% Wall thickness ( $r/t = 0.5$ )

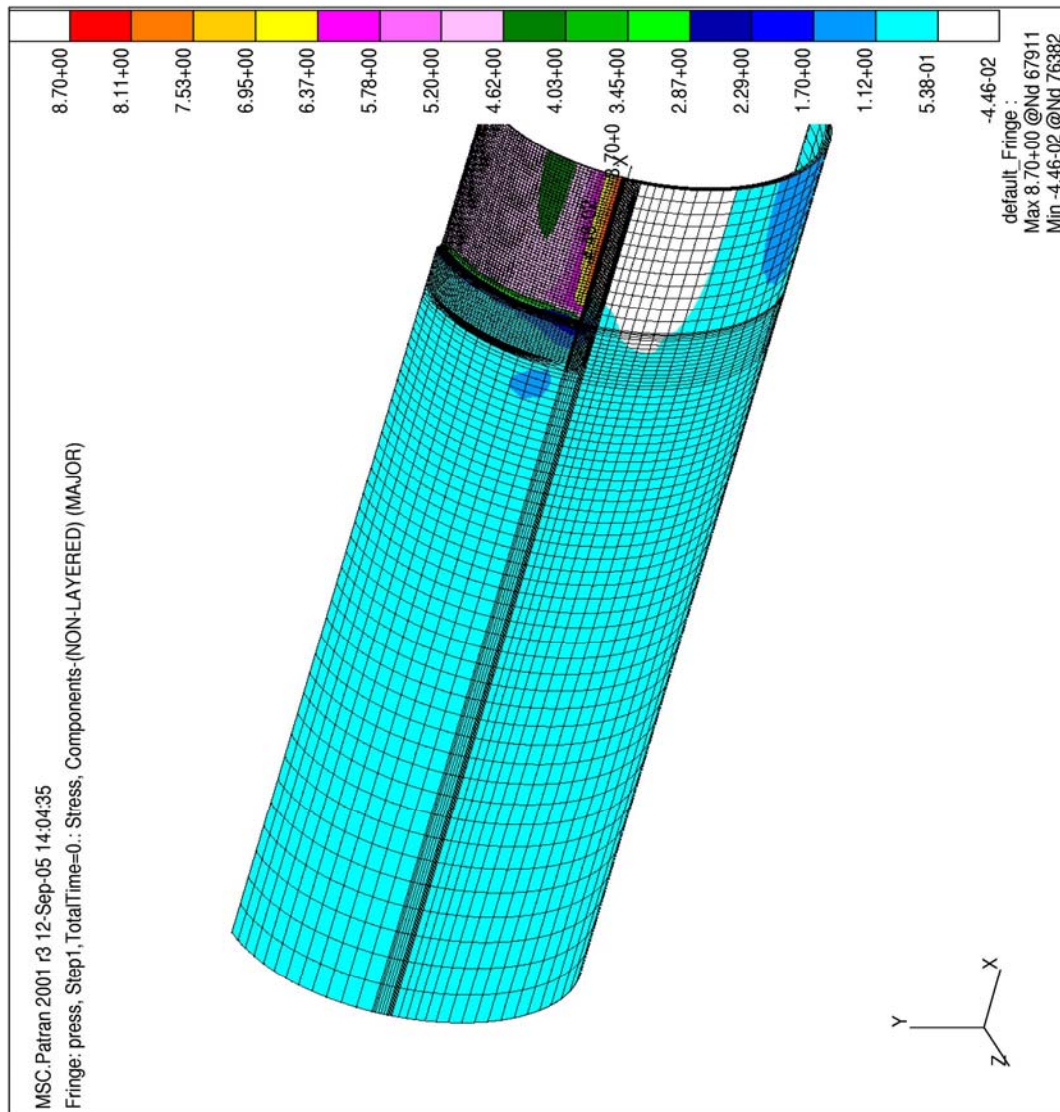
Figure 7 shows that maximum principal stresses at locations away from corrosion are apparently in the range  $0.54 \text{ N/mm}^2$  to  $1.12 \text{ N/mm}^2$ . This large apparent range is due to the automatic scaling of contour levels by the post-processing software. Further investigation shows that results were in the range  $0.93 \text{ N/mm}^2$  to  $1.1 \text{ N/mm}^2$ . The circumferential stress of the pipe with the internal pressure given by equation (1) is equal to unity, and hence provides confidence in the FE model. The highest maximum principal stress (HMPS) ( $8.7 \text{ N/mm}^2$  in Figure 7), which occurred in the corroded region, is defined as the stress concentration factor (SCF) for the corrosion defect. In most cases, the highest maximum principal stress occurred either around the centre of the corrosion shown in Figure 8 or around the corrosion transition region shown in Figure 9.

Figure 7 – Maximum Principal Stress of 914.4 mm x 12.7 mm Pipe with a Corrosion Size of 500 mm x 500 mm and a Depth of 80% Wall thickness

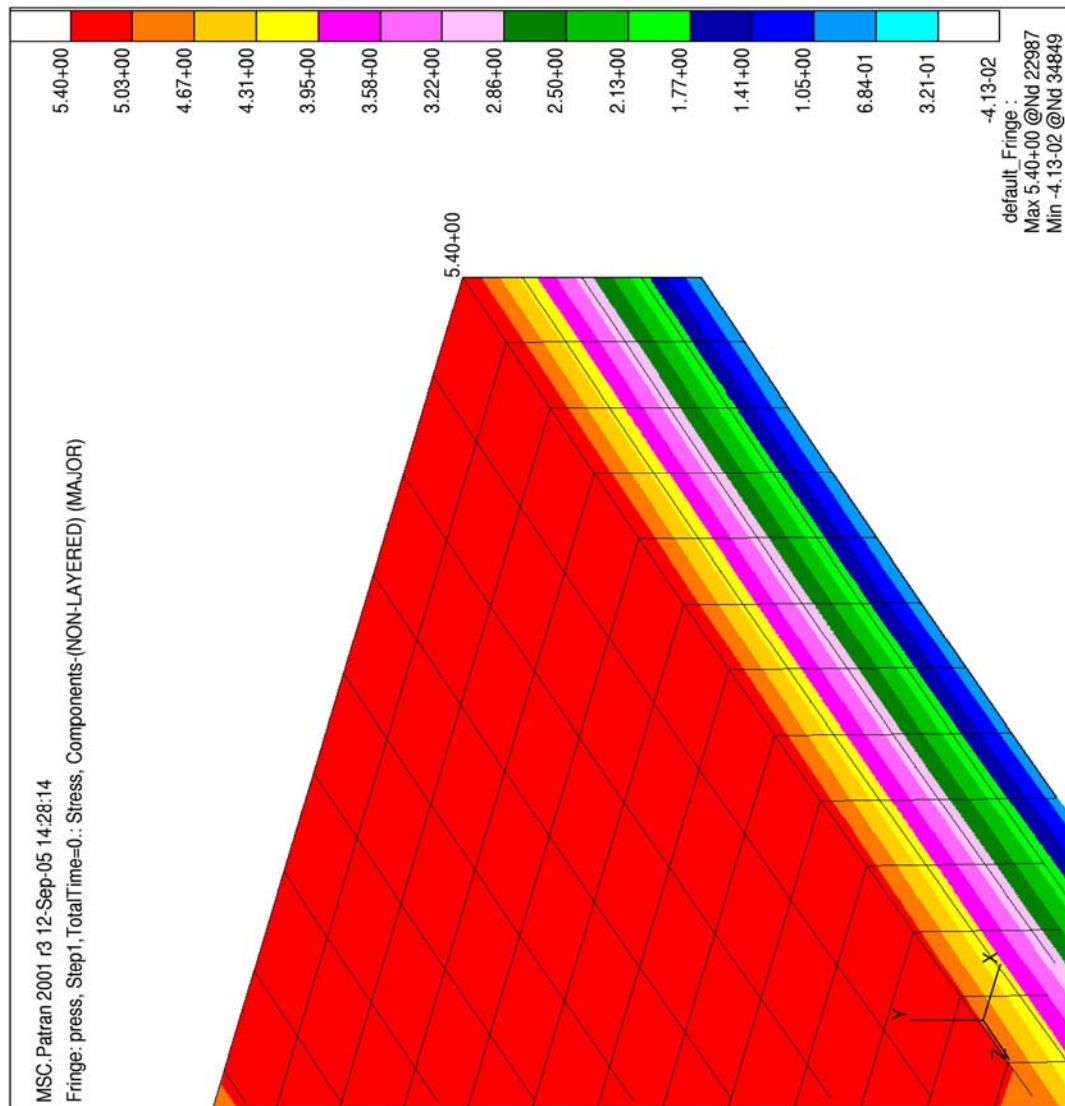
Figure 8 – Local View of Maximum Principal Stress of 914.4 mm x 12.7 mm Pipe with a Corrosion Size of 50 mm x 50 mm and a Depth of 80% Wall thickness

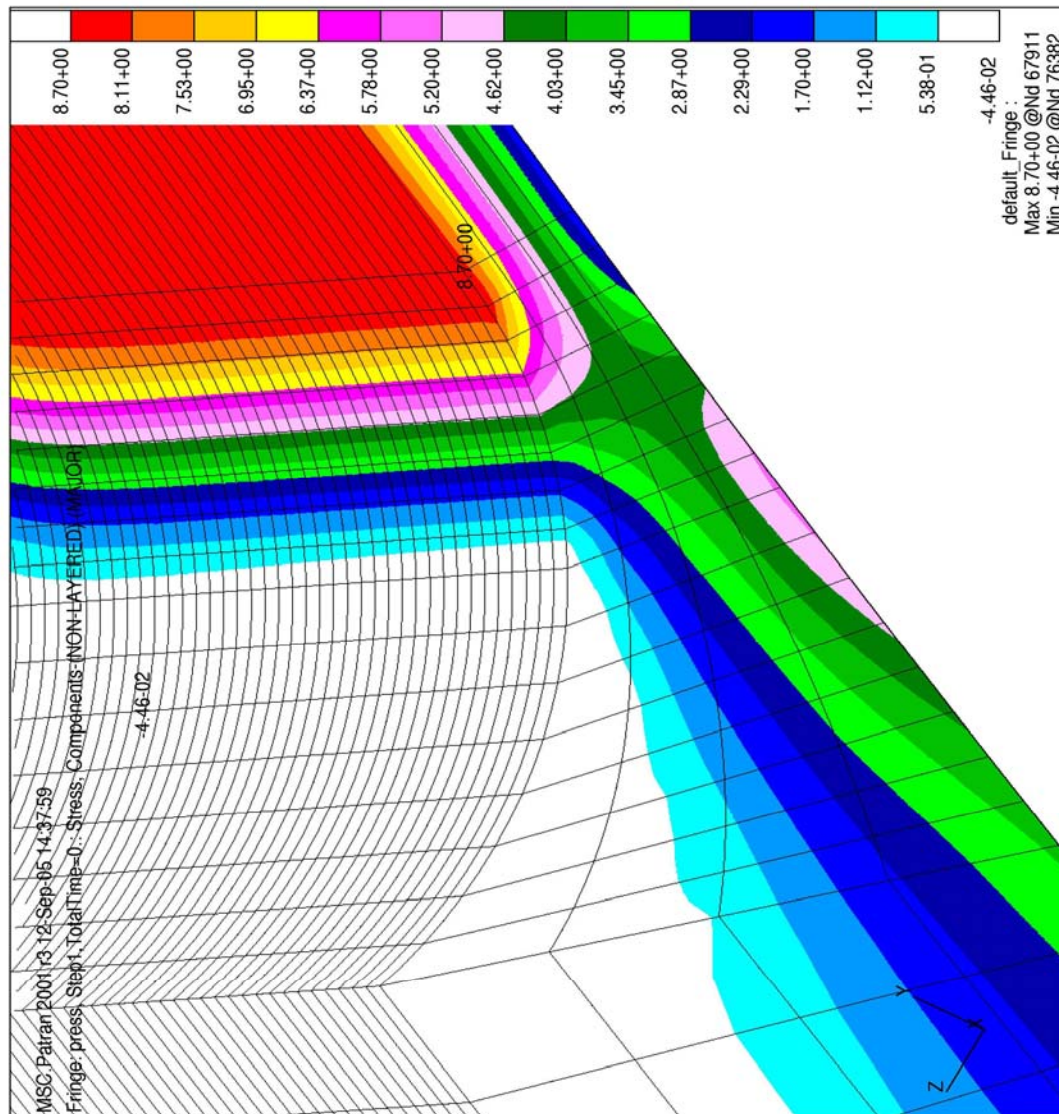
Figure 9 – Local View of Maximum Principal Stress of 914.4 mm x 12.7 mm Pipe with a Corrosion Size of 500 mm x 500 mm and a Depth of 80% Wall thickness

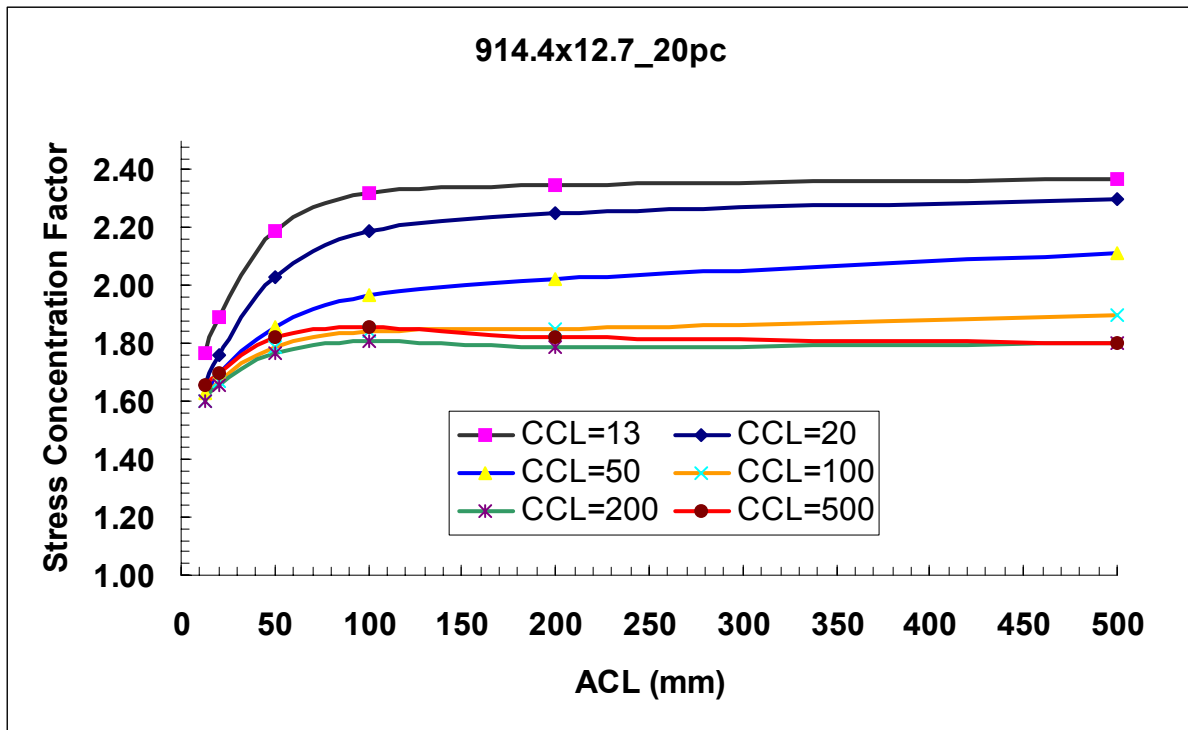
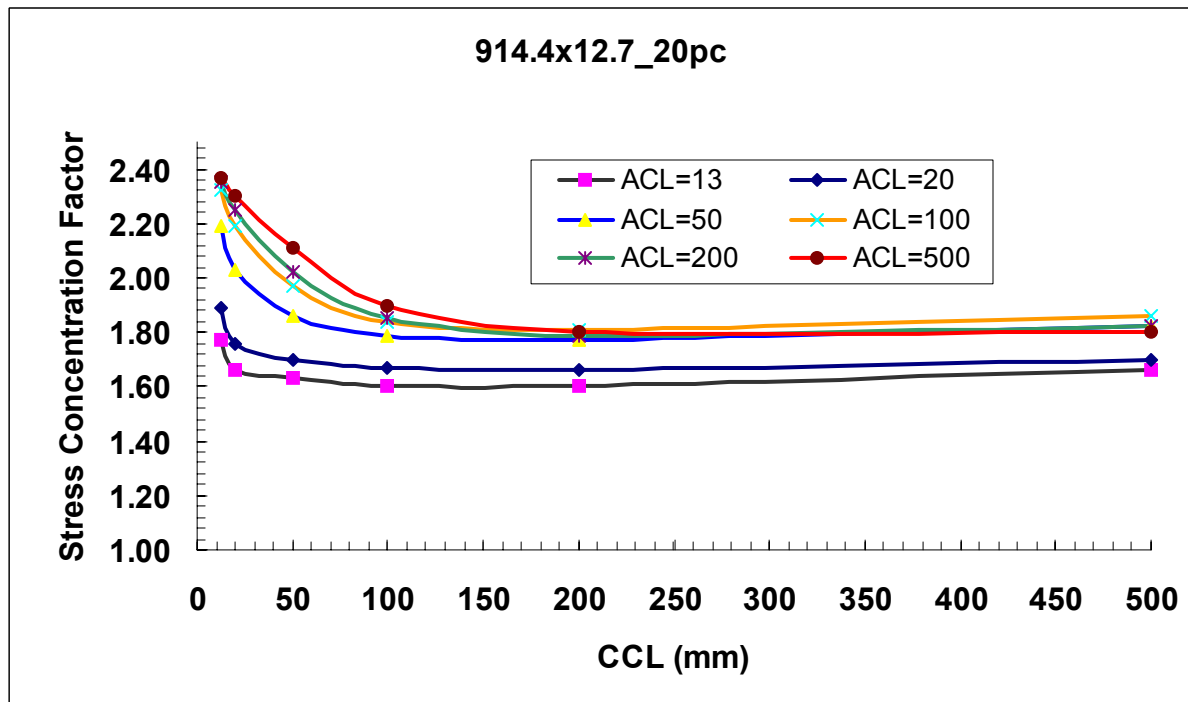
a): SCF with variation of axial corrosion length

b): SCF with variation of circumferential corrosion length

Figure 10 – SCFs of 914.4 mm x 12.7 mm Pipe with CD = 20%t and r/t = 1

The SCFs in Table 1 - Table 4 are from FE analyses on corroded pipes with  $r/t = 1$  and with  $CD = 20\%$ ,  $40\%$ ,  $60\%$  and  $80\%$  wall thickness, respectively. These SCFs are also plotted in Figure 10 - Figure 13 as functions of the ACL and CCL. The figures show that, in general, the SCF increases with an increase of ACL but decreases with an increase of CCL until it reaches an approximately constant plateau value. However, for corroded pipes with a short ACL (13 mm or 20 mm), the SCF may decrease with an increase of ACL and increase with a decrease of CCL, as clearly shown in Figure 12 and Figure 13.

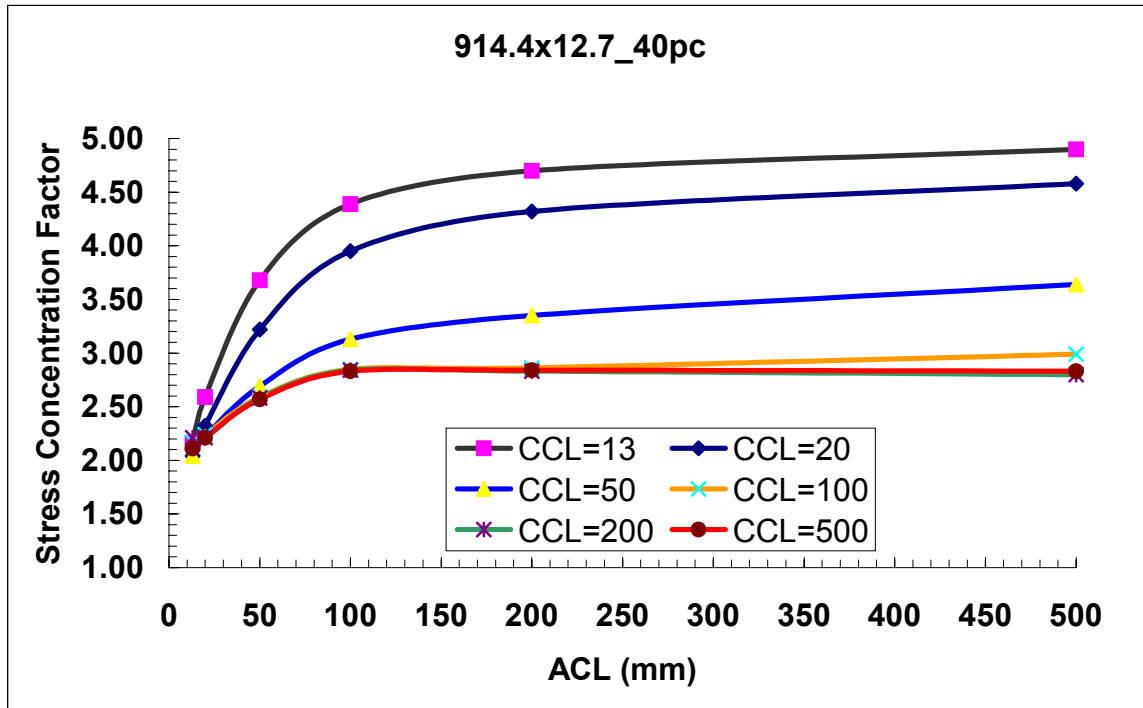
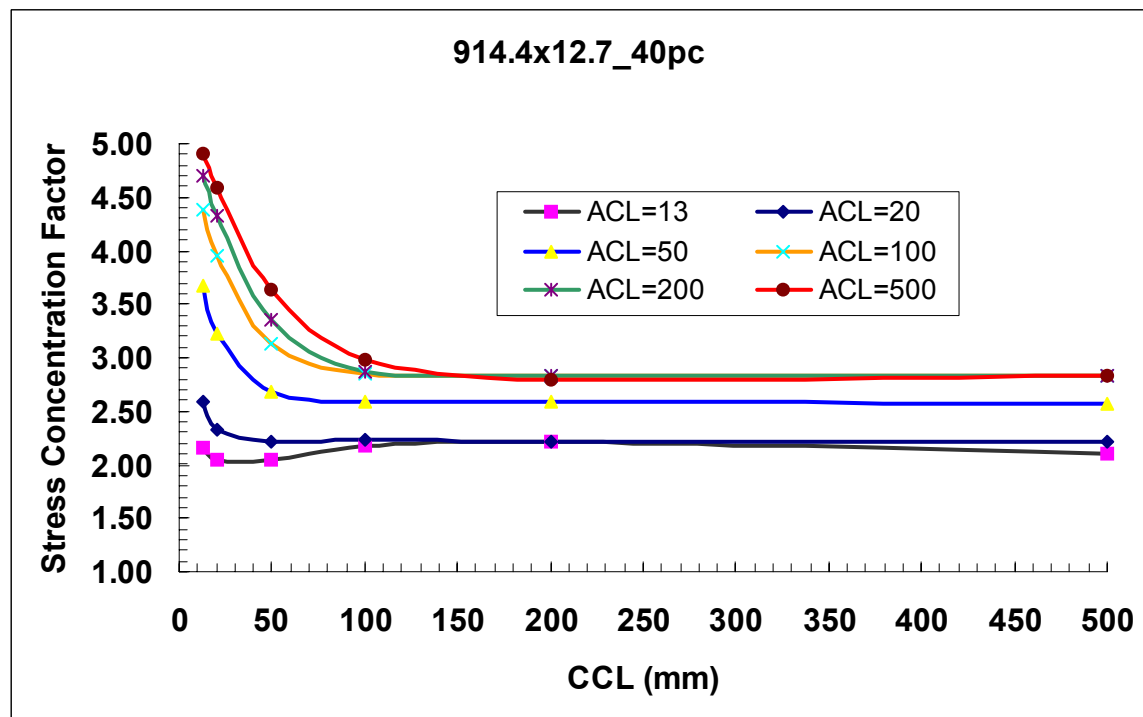
Figure 11 – SCFs of 914.4 mm x 12.7 mm Pipe with CD = 40%t and r/t = 1

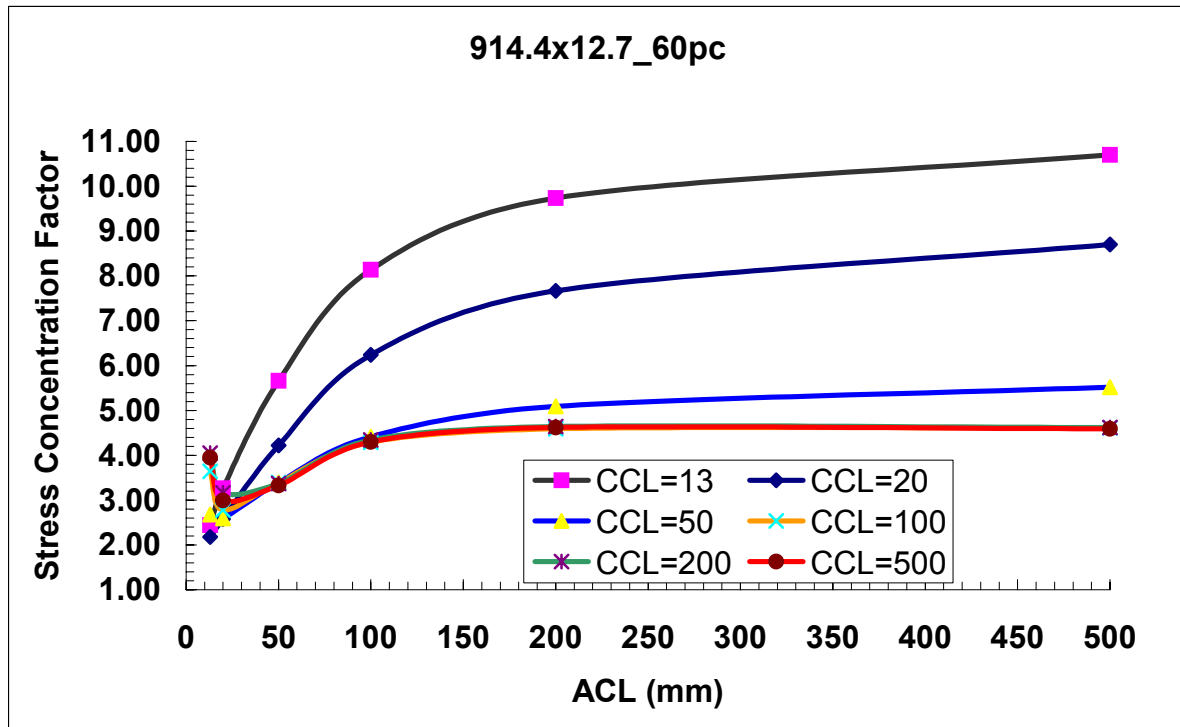
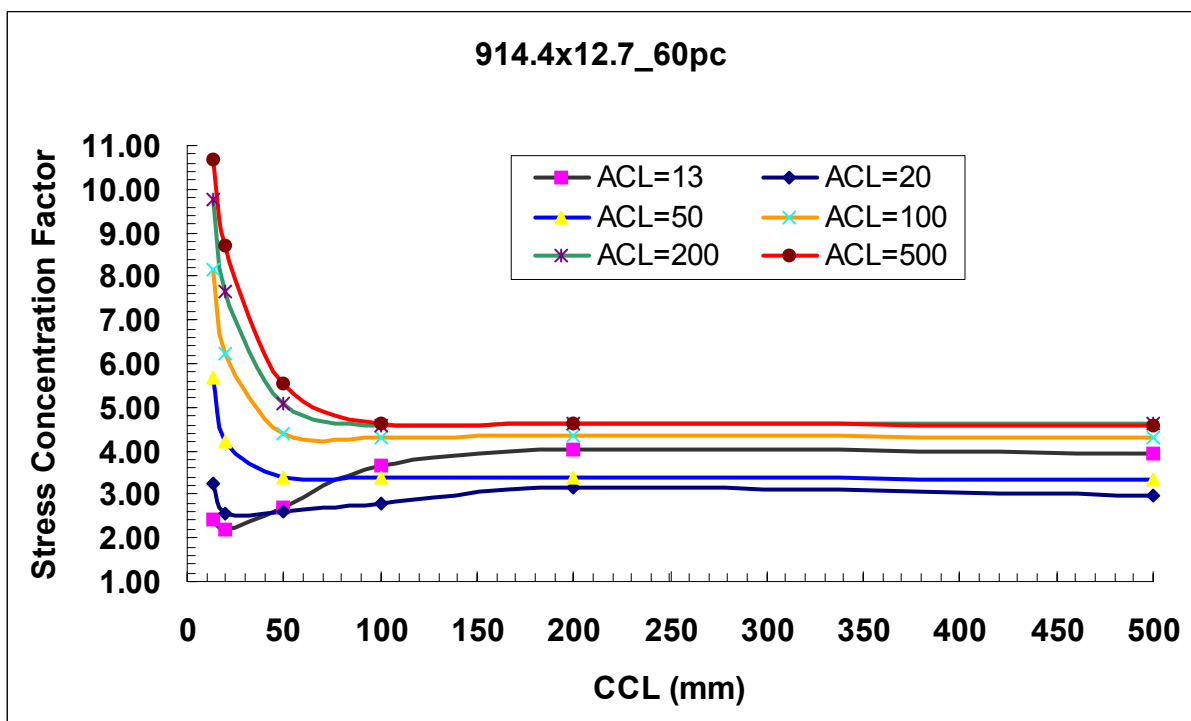
Figure 12 – SCFs of 914.4 mm x 12.7 mm Pipe with CD = 60%t and r/t = 1

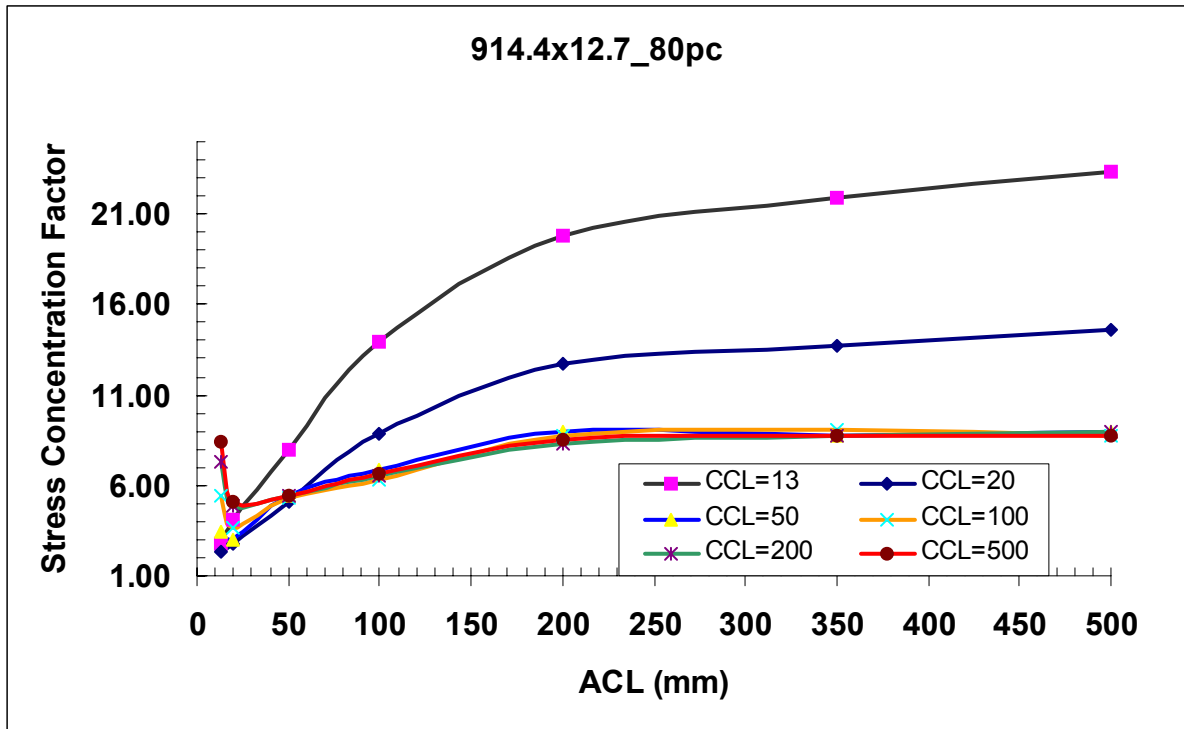
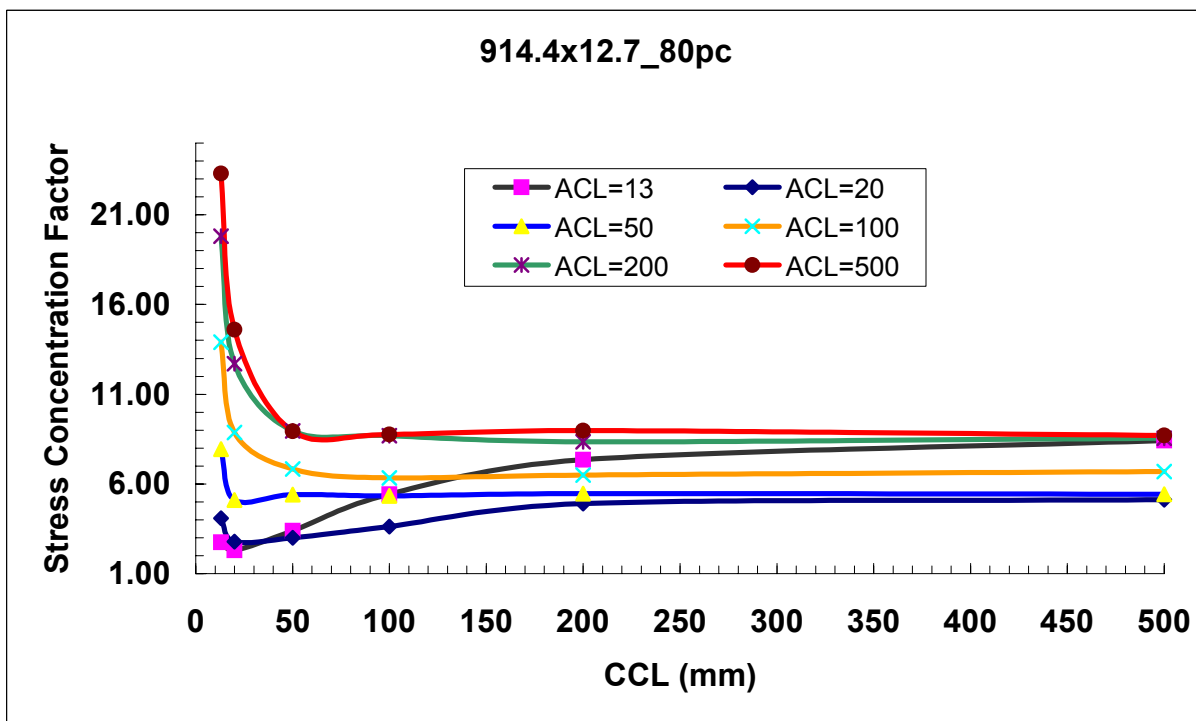
Figure 13 – SCFs of 914.4 mm x 12.7 mm Pipe with CD = 80%t and r/t = 1
